Thermal, hydraulic and mechanical stabilities of slopes covered with *Sasa nipponica*

ABSTRACT: Following a comprehensive field study evaluating thermal, hydraulic, and mechanical stabilities of a slope covered with *Sasa nipponica*, a type of dwarf bamboo (known as *Sasa*), against slope failure in a cold region (eastern Hokkaido in Japan), it was found that thermal stability increases due to a decrease in freezing and frost heaving of the surface layer caused by the adiabatic effects of *Sasa* litter and the snow it retained. Further, *Sasa* plays a role in reducing the effect of rainfall due to the water retention by the *Sasa* rhizome layer in the surface soil, thereby increasing hydraulic stability. Through surveys of surface failures caused by an earthquake in places on wild slopes covered with *Sasa*, the mechanical stability was evaluated using the safety factor in a static condition expressed as a function of the leaf area index (LAI), which exceeds 1.37, owing to the reinforcing effect of the rhizomes.

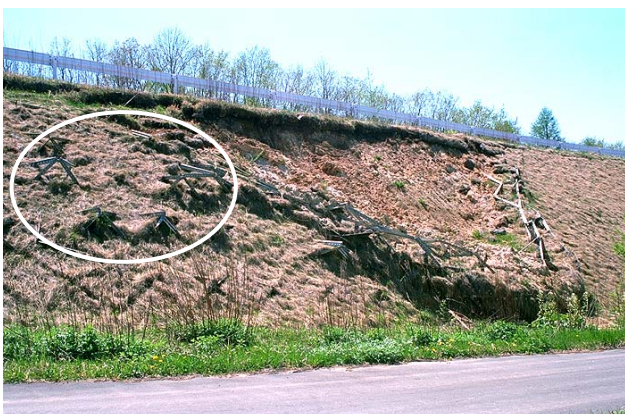
Figure 1. Surface failure on the artificial slope and frost heave damage to protective grids, marked with a circle (left).

On the artificial slopes along roads in cold regions, slope surface failure and erosion occur occasionally owing to frost heave damage to protective grids, which usually cease to function because they protrude from the ground surface due to repeated freeze–thaw cycles, as shown in Figure 1. In Japan, these grids are generally used to keep the planting ground on steep slopes stable, but the damage is mainly concentrated in eastern Hokkaido, as shown in Figure 2 (Takeda et al. 2000). On the other hand, hardly any damage occurs on native slopes covered with *Sasa nipponica* Makino et Shibata (called *Sasa*), a type of dwarf bamboo, especially to grow in such the cold region, which has less snow, illustrated in Figures 2 (Hokkaido 1983) and 3.

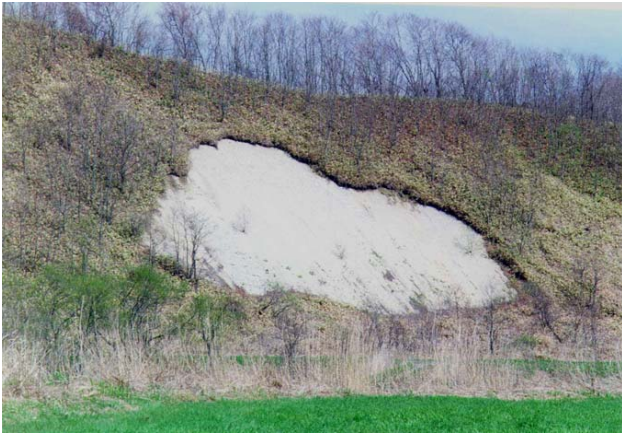
Figure 5. Surface failure on the wild slope covered with *Sasa nipponica* induced by the earthquake.

To evaluate the stability of the surface layer on slopes reinforced by *Sasa*, field surveys and laboratory tests were conducted on the native slope covered with *Sasa* on which partial sliding surface failures occurred due to the earthquake (January 1993, M7.8) at Taiki, as indicated by ③ in Figures 2 and 5. The following procedures were carried out: (1)

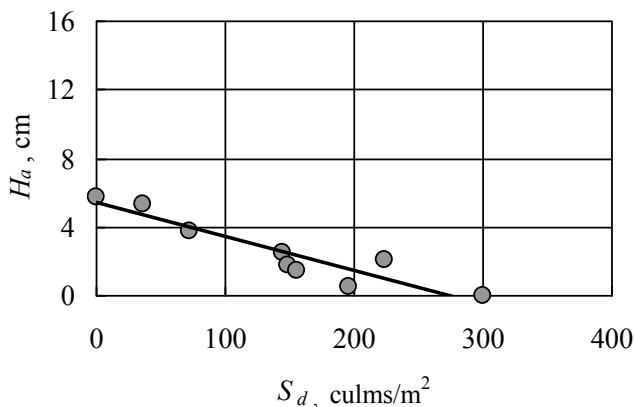
Figure 7. Relationship between the seasonally maximum frost heave amount H_a and the culm density of *Sasa nipponica* S_d .

As shown in Figures 6 and 7, both the seasonally maximum values of frost depth F_d (cm) and heave amount H_a (cm) decrease with increasing of culm density S_d (culms/m²), given by the following equations:

$$H_a = -0.0198 S_d + 5.40 \quad (2)$$

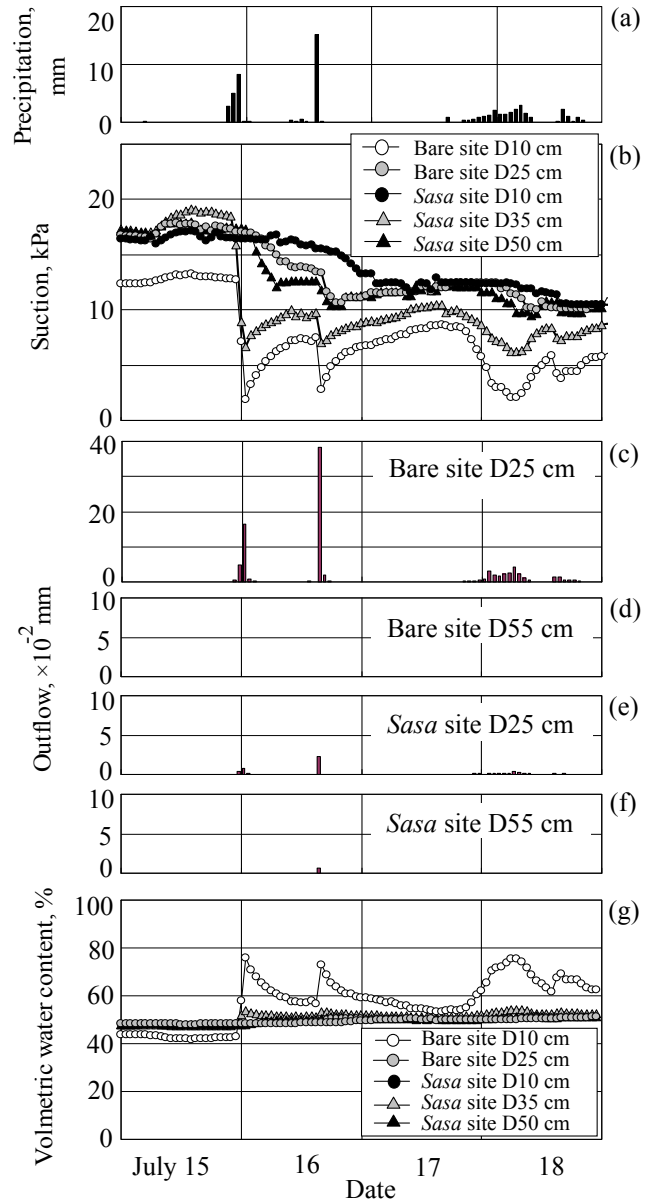
Figure 8. Changes of precipitation (a), suction (b), outflow (c) – (f), and volumetric water content (g) at the *Sasa* and bare sites on the slope.

During the observation, two rainfalls offered suitable opportunities to observe large changes in the suction (July 15–18 and September 24–25). Observation results for the former event are shown in Figure 8, which shows changes in precipitation, suction, and outflow. The suction responds sensitively to the two peaks of precipitation, 8.5 and 15.2 mm/h. Also, the outflow changes considerably on the surface of the bare site (25 cm in depth), while there is hardly any change at 25 cm below the *Sasa* mat. Using the soil moisture characteristic curve obtained in laboratory tests, the suction is converted into the volumetric water content, as presented in Figure 8 (g). During

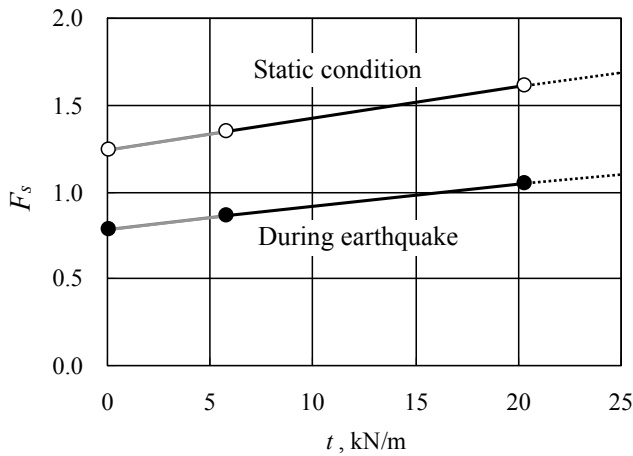
Figure 10. Relationship between safety factor F_s and tensile force of *Sasa* rhizomes per unit slope length t .

As shown in Figure 10, the safety factor during the earthquake is determined to be about 1.0; thus, the result can be considered relevant, because five surface failures were found distributed on slopes in the range of 1 km. For the other two failures of them analyzed in the same manner (Takeda et al., 2001), the factors were about 1.0. Next, assuming that we can apply these values to the estimation of the safety factor in the static condition, it was determined to be 1.26 on the slope without *Sasa*, and more than 1.37–1.65 using t values of 5.8–20.3 kN/m. Therefore, it was found that the increases in the factor with the tensile force indicate the reinforcing effect of rhizomes on the surface layer of the slope, while the factor for the slope without *Sasa* is dependent on the strength parameters of soils at the sliding surface.
